30978.000
Mukilteo Library
Leak Investigation

DATE November 18, 2024

REGARDING **Follow-Up Leak Investigation Summary Letter**

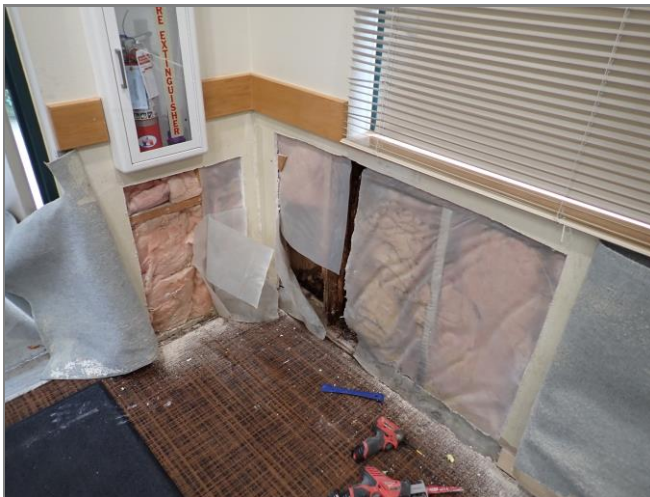
Interior drywall and fabric overlay was removed below the east end of the aluminum framed window to review the water damaged wood framing.

RDH observed that the wood stud framing, wood sill top plate end and exterior wall plywood sheathing were decayed. The bottom sill plate wood support secured to the concrete slab on grade was decayed as well. The majority of the water damage was observed below the east end of the window but additional damage to wood components was also observed on the opened east elevation wall cavity and west of the windowsill corner.

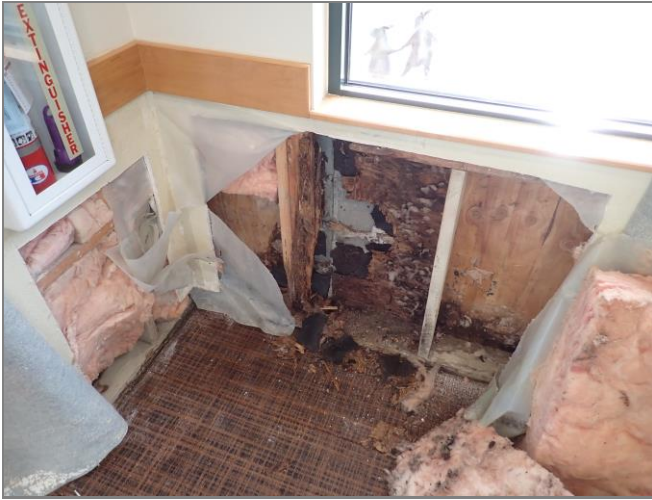
The interior side vapor barrier was opened to review the extent of water damaged wood framing.

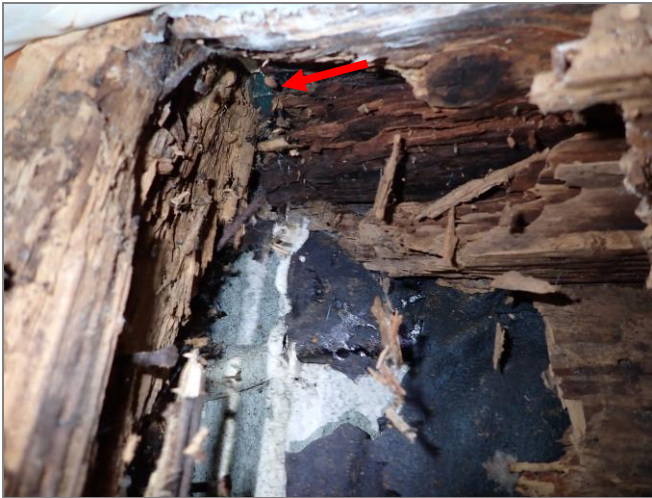
Within the opening, the wood sill top plate support had severely decayed leaving the corner of the window frame exposed (red arrow).

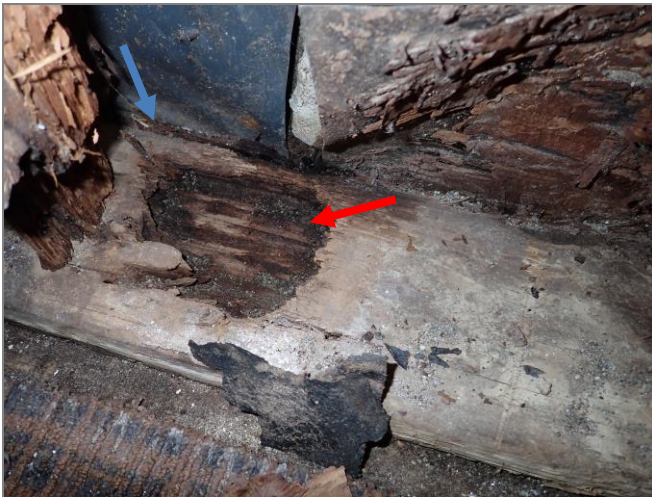
Severe decay was observed at the supporting sill plate directly below the east end corner of the window (red arrow). Note an accumulation of dirt was observed between the sill plate and the CMU veneer plastic masonry flashing (blue arrow).

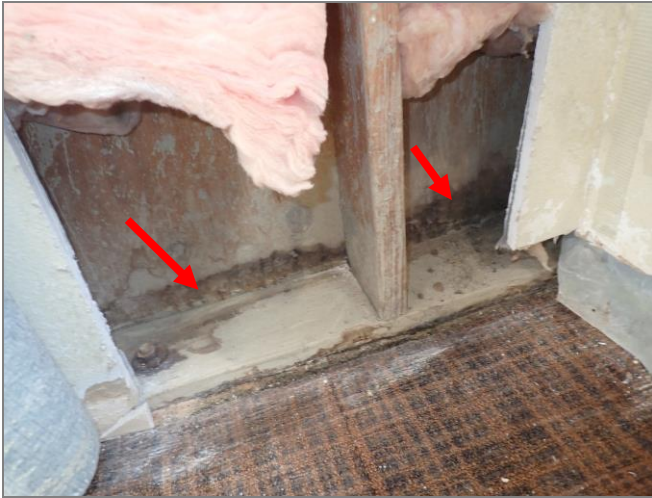
Water damaged exterior plywood sheathing was observed on the opened east elevation wall cavity. The supporting sill plate appears to be mostly intact with some softness noted on select portions on the interior side edges.

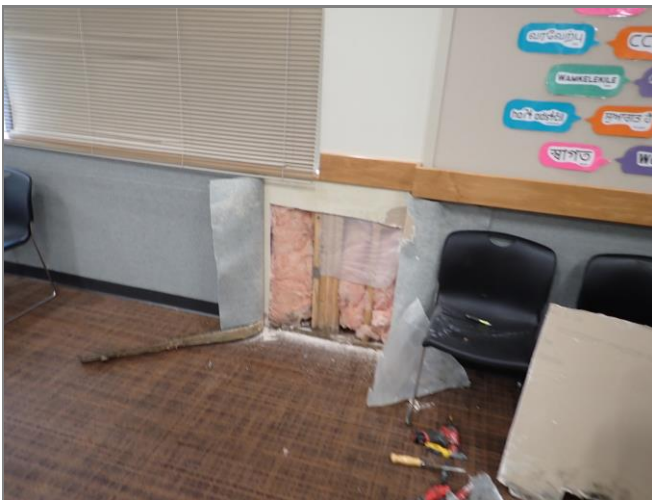
An opening was performed below the west end of the aluminum framed window to expose the wall cavity for review.

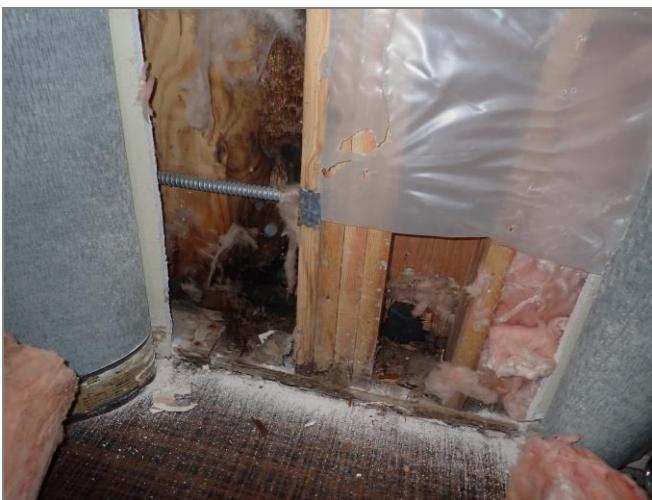
Water damaged exterior plywood sheathing was observed. Water staining with some minor water damage was observed for the wood stud and sill plate framing.

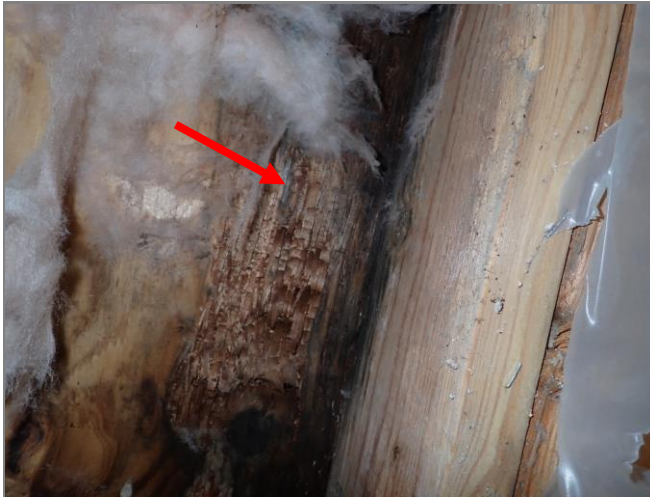
Water damaged exterior plywood sheathing was observed below the window sill corner.

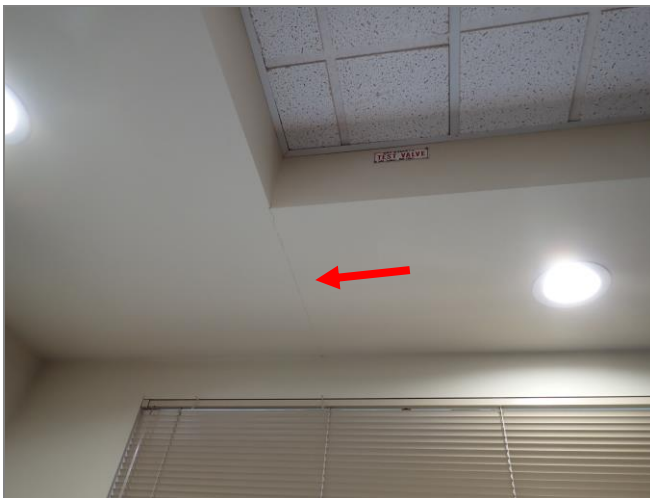
Aaron Pambianco of AJP Engineering reviewed the wood stud framing that was exposed. Mr. Pambianco noted that the south elevation wall is not a load bearing wall and that the slab on grade concrete had not been compromised where the water damaged conditions were observed. Mr. Pambianco observed stress cracks in the ceiling gypsum board and at corners of the interior drywall at the head of the window. From both AJP's and RDH's on-site observations, we noted that the window is experiencing some movement due to the lack of support at the east end. It was recommended that the wood bracing be added to on the east end of the window in the interim for additional support. A summary email was prepared noting his recommendations for temporary bracing of the decayed wood stud frame and sill plate as well as future repairs.

Stress crack in ceiling gypsum board was observed.

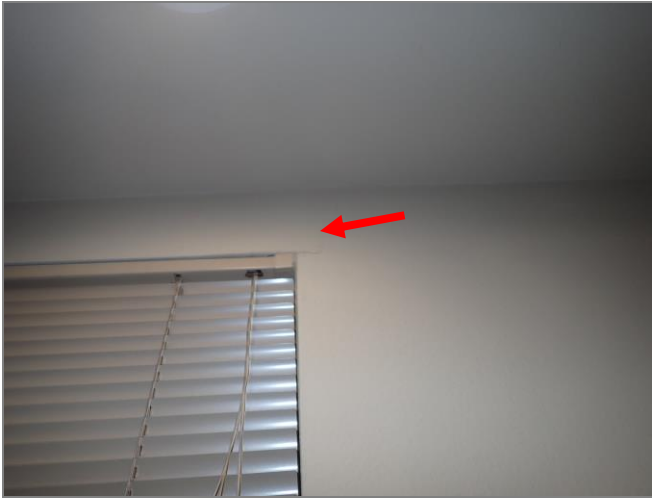
Additional cracking was observed in the interior drywall at the head of the window.

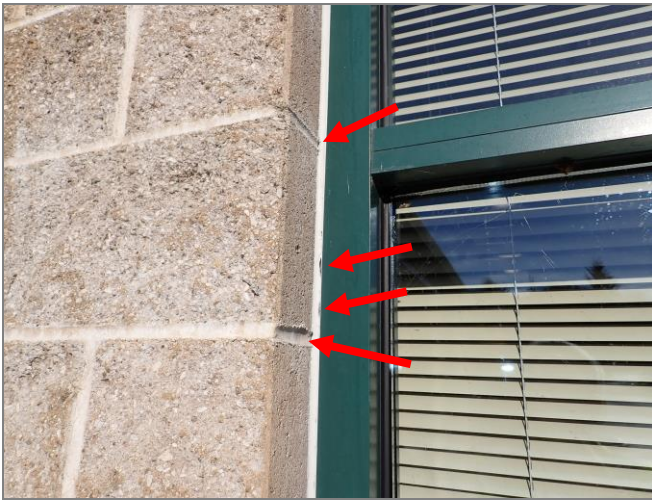
During the site visit performed on September 30, 2024, we observed some separation in the sealant joint at the west end window jamb (red arrows).

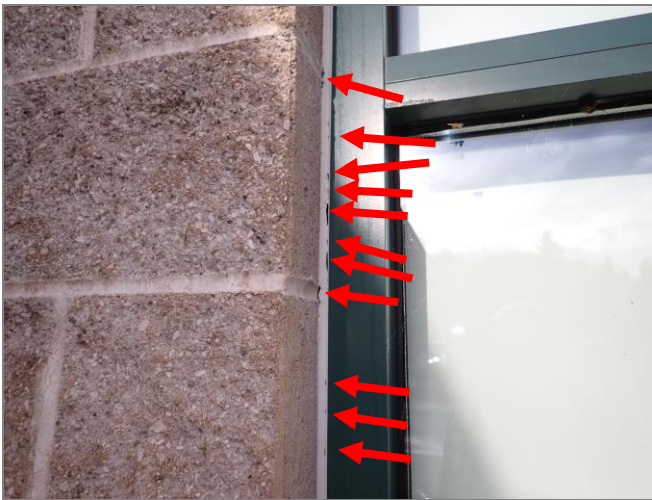
During the follow-up site visit, several openings were observed in the same sealant joint at the window jamb with the previously observed openings becoming larger (red arrows).

Water has entered the interior through multiple pathways on the exterior wall. The window frame is set to the CMU veneer which does not allow for a proper sealant joint. Normal expansion and contraction of the window frame has stressed the applied sealant and created openings in the sealant over time. There are open joints at the head of the window to veneer interface that are additional pathways for water to enter behind the frame. No control joints are present in the CMU veneer to compensate for movement. The missing control joints have created cracks in the mortar joints that allow water behind the veneer system. To further compound this condition, the concrete slab poured to the base of exterior wall prevents water from draining through weep openings in the CMU veneer. Any water that enters behind the masonry system becomes trapped within the wall assembly. We also noted that the exterior glazing gaskets have shrunk and created openings at corners for water to enter.

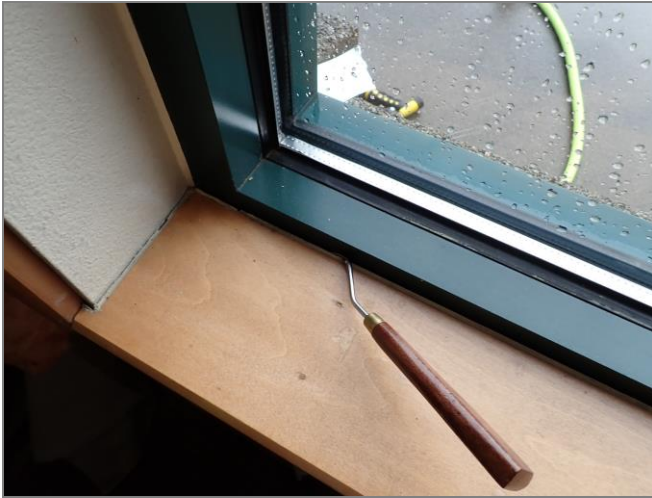
A gap was observed between the interior side wood sill trim and the window sill frame at the east end of the window.

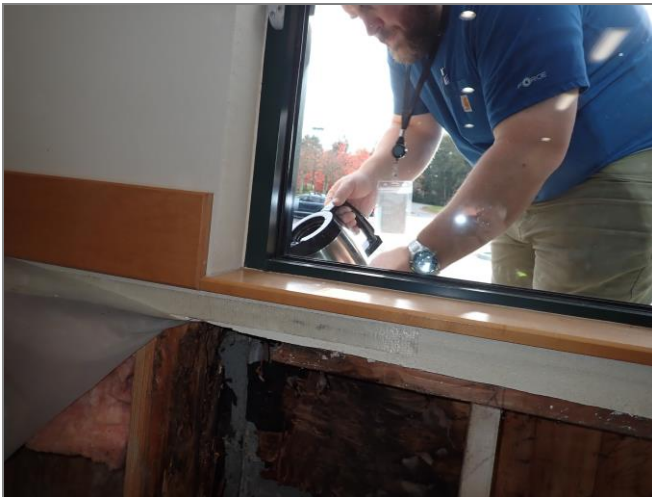
While on-site, water was placed on the exterior windowsill corner to review potential pathways for the water intrusion. Water was first poured at the east end of the windowsill frame that interfaces with the CMU veneer. We observed water entering through the frame interface as well as an open joint in the CMU veneer. The interior side joint of the veneer continues vertically from the windowsill down to the slab on grade concrete.

Water being poured at the window sill corner.

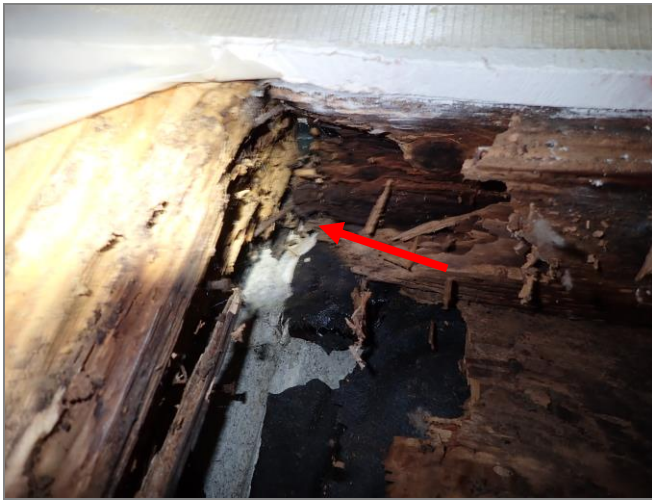
Water was observed entering at the window sill corner first (red arrow).

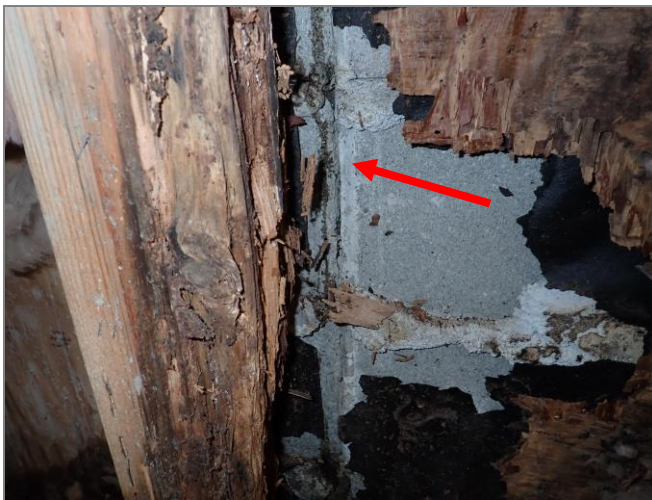
Water was also observed entering through an open joint in the CMU block veneer.

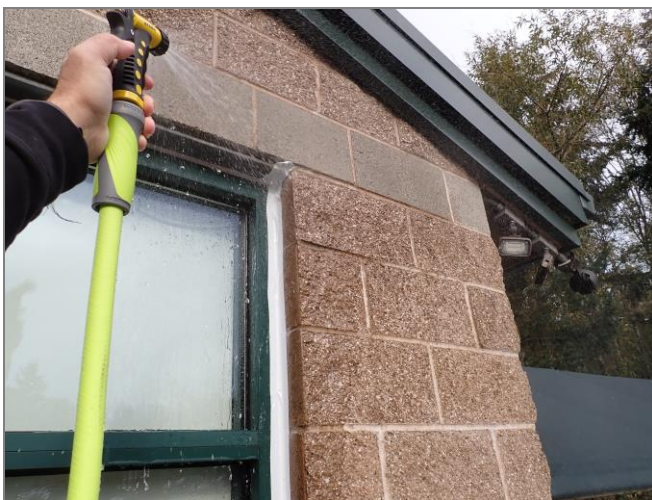
Water was then applied at the head of the window on the exterior side of the wall. PVC tape was used to cover the window jamb and sill sealant joint to isolate the water pathway. During the water testing at the head of the window, water was observed entering the interior

Water applied at the head of the window.

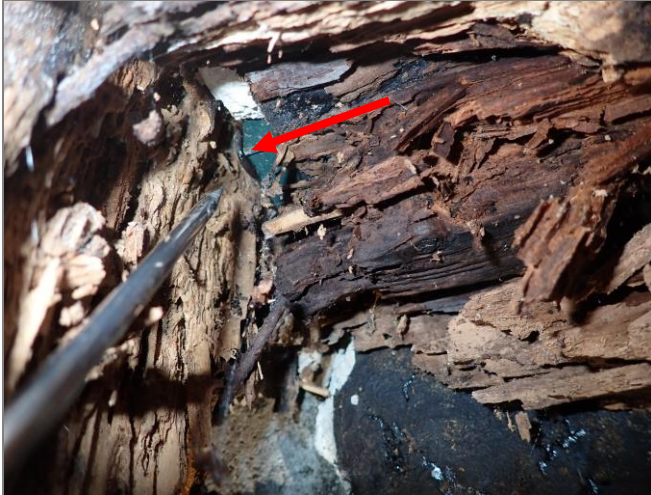
During the testing, water was observed on the backside of the sill frame (red arrow) indicating another pathway for water to enter the interior.

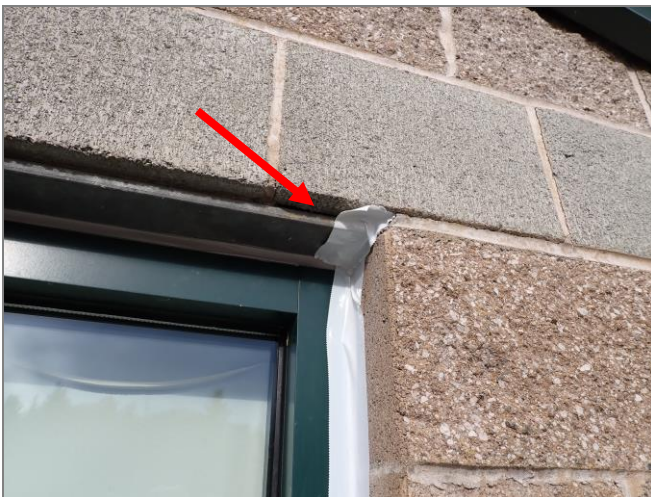
An opening is present where the steel ledger interfaces with CMU veneer.

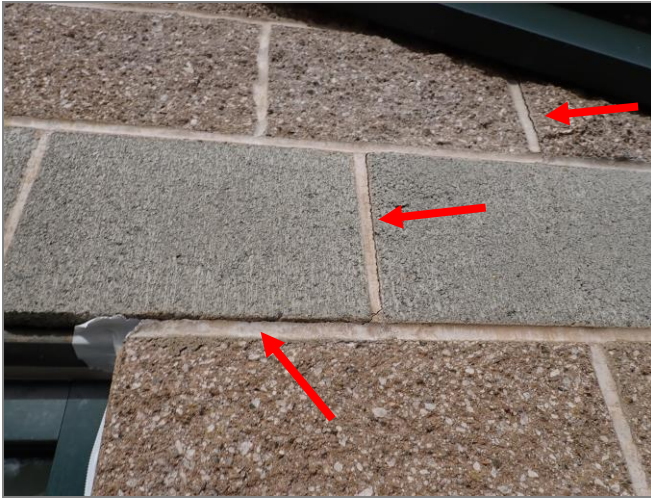
Without control joints in the masonry wall, cracks develop in the mortar joints (red arrows) and are pathways for water to enter behind the veneer.

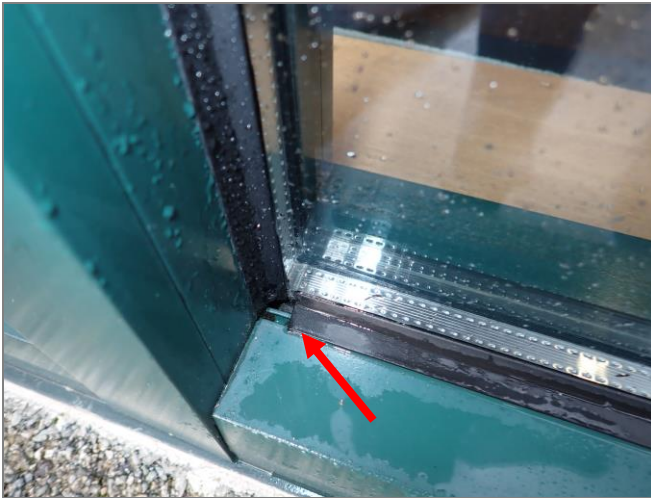
Openings at the corners of the glazing gaskets were observed.

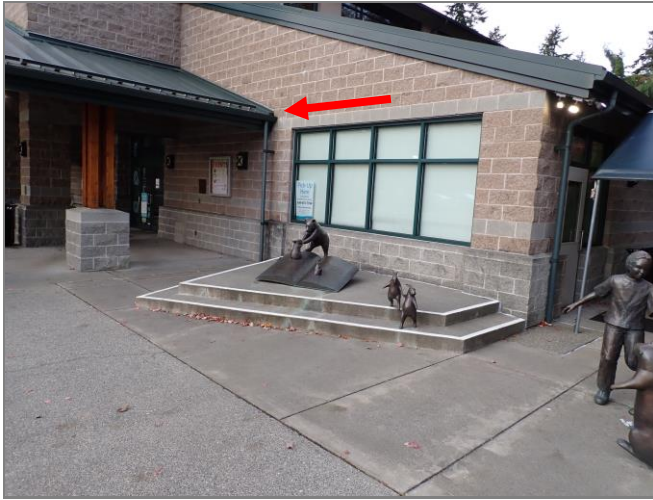
From our on-site review, the east end of the window experiences more of the weather conditions as it is exposed. The west end of the window is partially protected with the eave edge of the main entrance sloped roof hence the less severe water damage at this end.

The west end of the window has some partial coverage with the sloped roof eave edge.

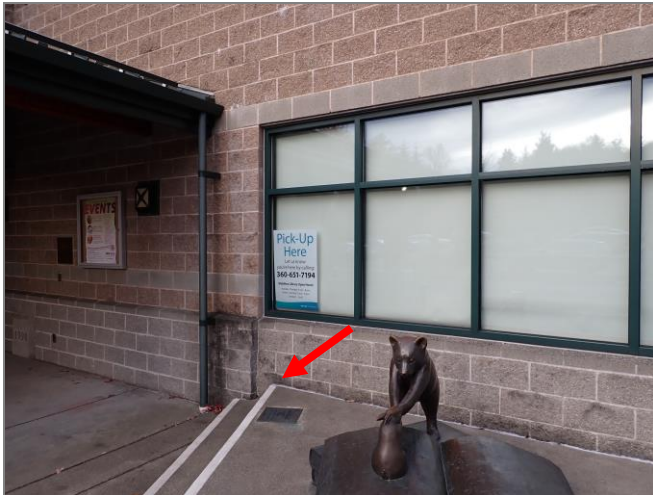
Also the concrete slab poured to the CMU veneer wall is less than the east side leaving the potential for some water drainage at this end.

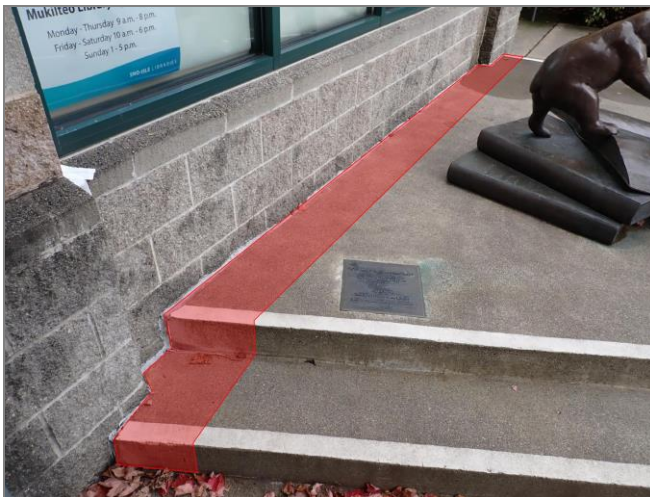
Proposed poured slab removal section.

TABLE 3.1 CONCEPTUAL REPAIRS	
	<ul style="list-style-type: none"> • Remove a portion of the poured feature slab from the base of the exterior wall. • Remove the CMU masonry below the window and at the window jambs. Salvage the CMU masonry for reinstallation. • As recommended by the Structural Engineer, remove the interior drywall around the window to review the wood framing for any potential damage. Structural Engineer to provide recommendations for repairs for damage that is observed. • Install new water resistive barrier membrane with self-adhering strip flashing to replace the damaged and/or missing flashings at the window

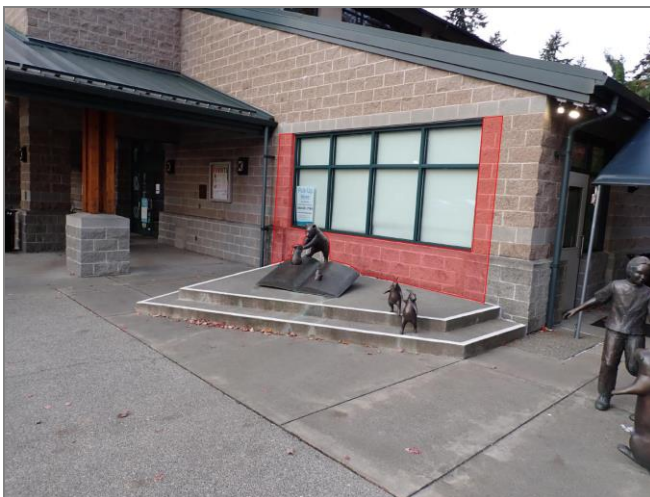
Proposed CMU veneer removal portion.

- rough opening. During this phase, the window will need to be examined and re-secured to the rough opening frame.
- Prior to reinstalling the CMU masonry, perform water test to confirm new waterproofing provides a watertight seal.
 - Re-install CMU masonry after a successful water test.
 - Install new waterproofing and means for water drainage at the base of the reinstalled CMU block. This is needed if the removed concrete slab portion needs to be replaced. Another consideration would be to install a grate covering so that access to the base of exterior wall can be provided for future maintenance and repairs.
 - Complete repair to interior finishes.

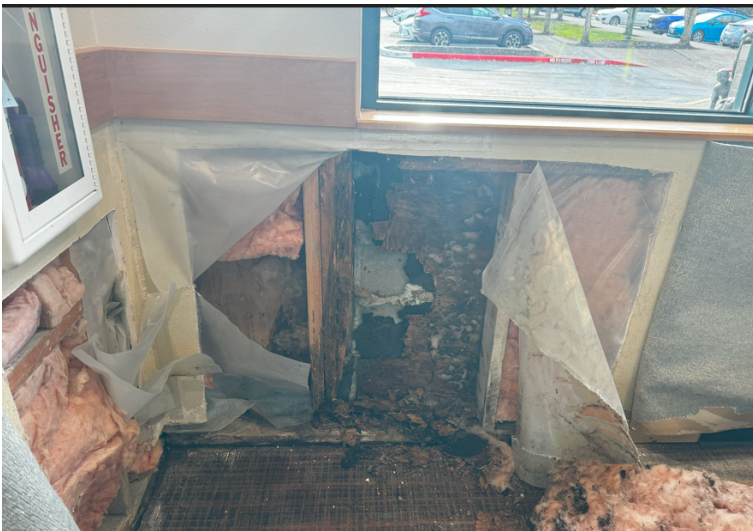
North:

I observed substantial plywood and stud degradation at the north corner and plywood degradation at the south corner. The exterior face was clad in split-face CMU veneer, only minimal cracking was observed at the veneer.
